# Drivers of permafrost degradation along the Inuvik to Tuktoyaktuk Highway

## Study Area

Inuvik to Tuktoyaktuk Highway (ITH), Northwest Territories, Canada.

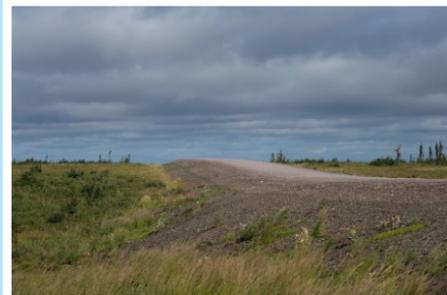
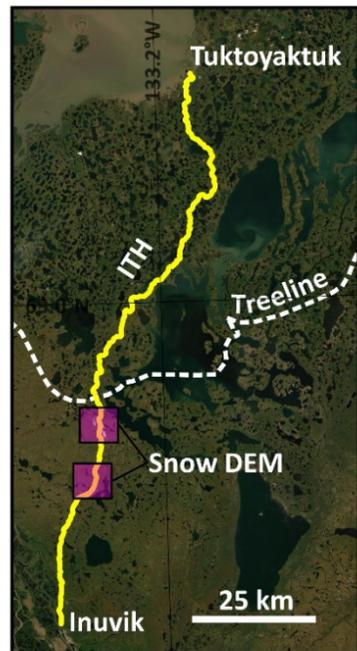
Side-view of road embankment. [3D view ITH](#)

The construction started in 2014 and the opening was in 2017.

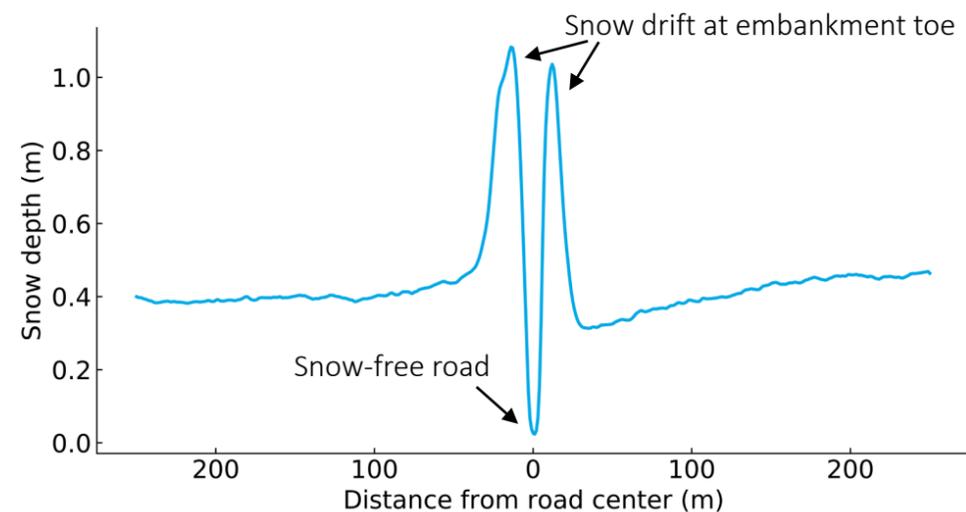
**Enhanced snow accumulation** within 47 m from the road.

Average snow depths of > 1 m next to the road.

Mean snow depth derived from 500 m long transects (n=3185) of ITH close to Trail Valley Creek from snow-free (August 2018) and snow-covered (April 2019) Digital Elevation Models.

Increased snow cover will increase the **thermal insulation** as well as produce **more melt water** and likely promote permafrost degradation.

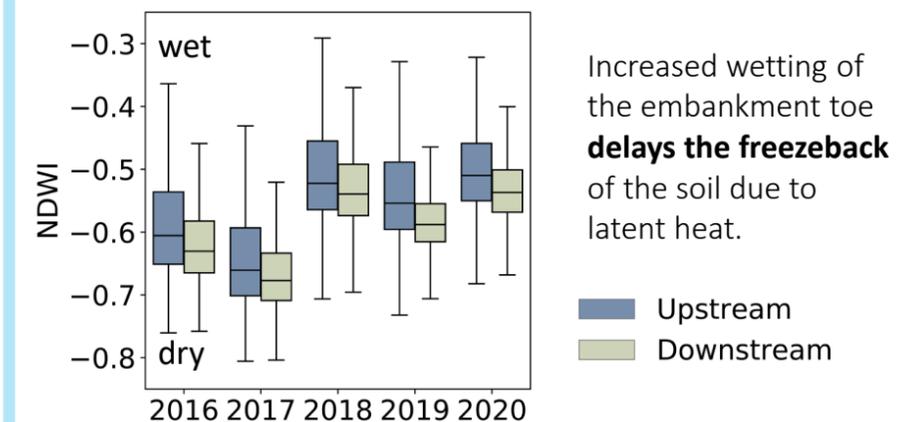
The difference between upstream and downstream from the road increases every year. NDWI generally increases.

Normalized Difference Water Index (NDWI) derived 50 m around every culvert from Sentinel-2 imagery (10 m resolution).

Additionally, even with culverts, embankments can hinder water movement and lead to wetting at the embankment.

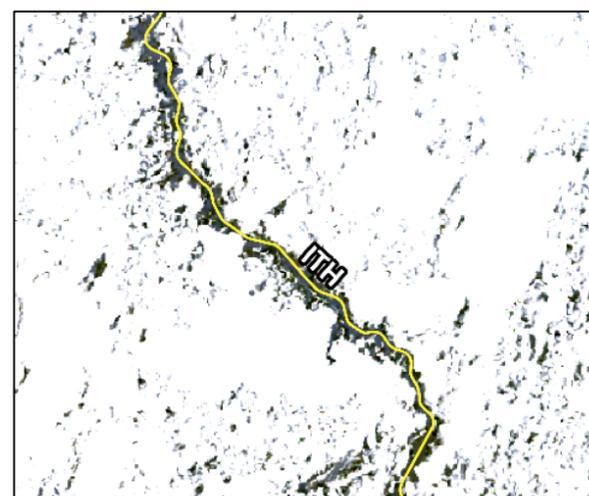
Example of partly snow covered true color Landsat 8 image from 2018-05-30.

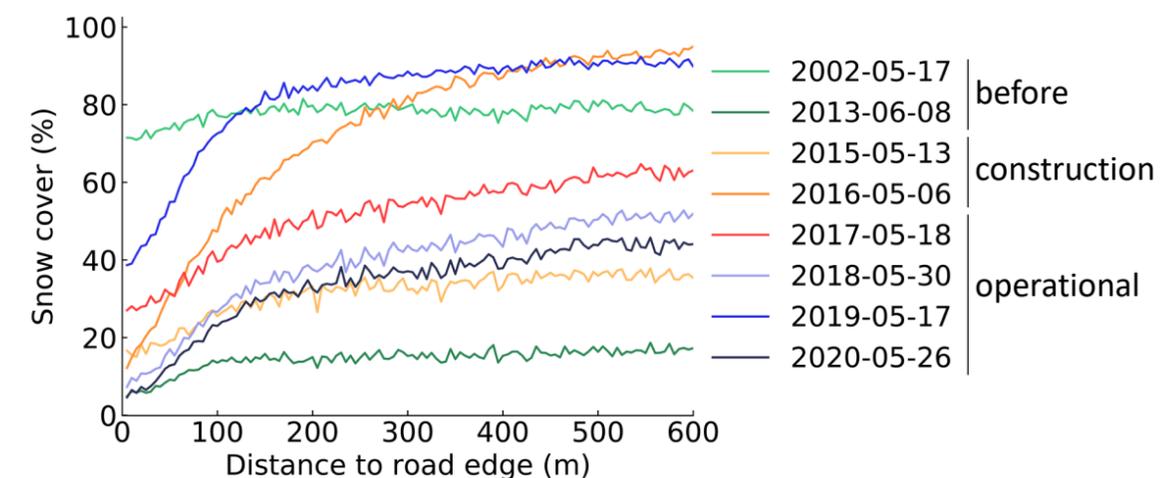
Areas next to the road become snow free **earlier** in spring than the areas further away.

Effects up to 400 m from the road edge.

Snow-cover derived from Normalized Difference Snow Index using Landsat 8 images (30 m resolution).

May trigger **ecological feedbacks** such as **early greening** and **warming** of the regions adjacent to the road.
