Permafrost soils as a Pollutant Barrier – are Organic Contaminants released from failing Drilling Mud Sumps in the Mackenzie Delta?

The BMBF-funded project “Thawing industrial legacies in the Arctic – a threat to permafrost ecosystems” (**ThinIce**) investigates the short and long-term environmental risks associated with the potential release of contaminated industrial wastes due to permafrost thaw.

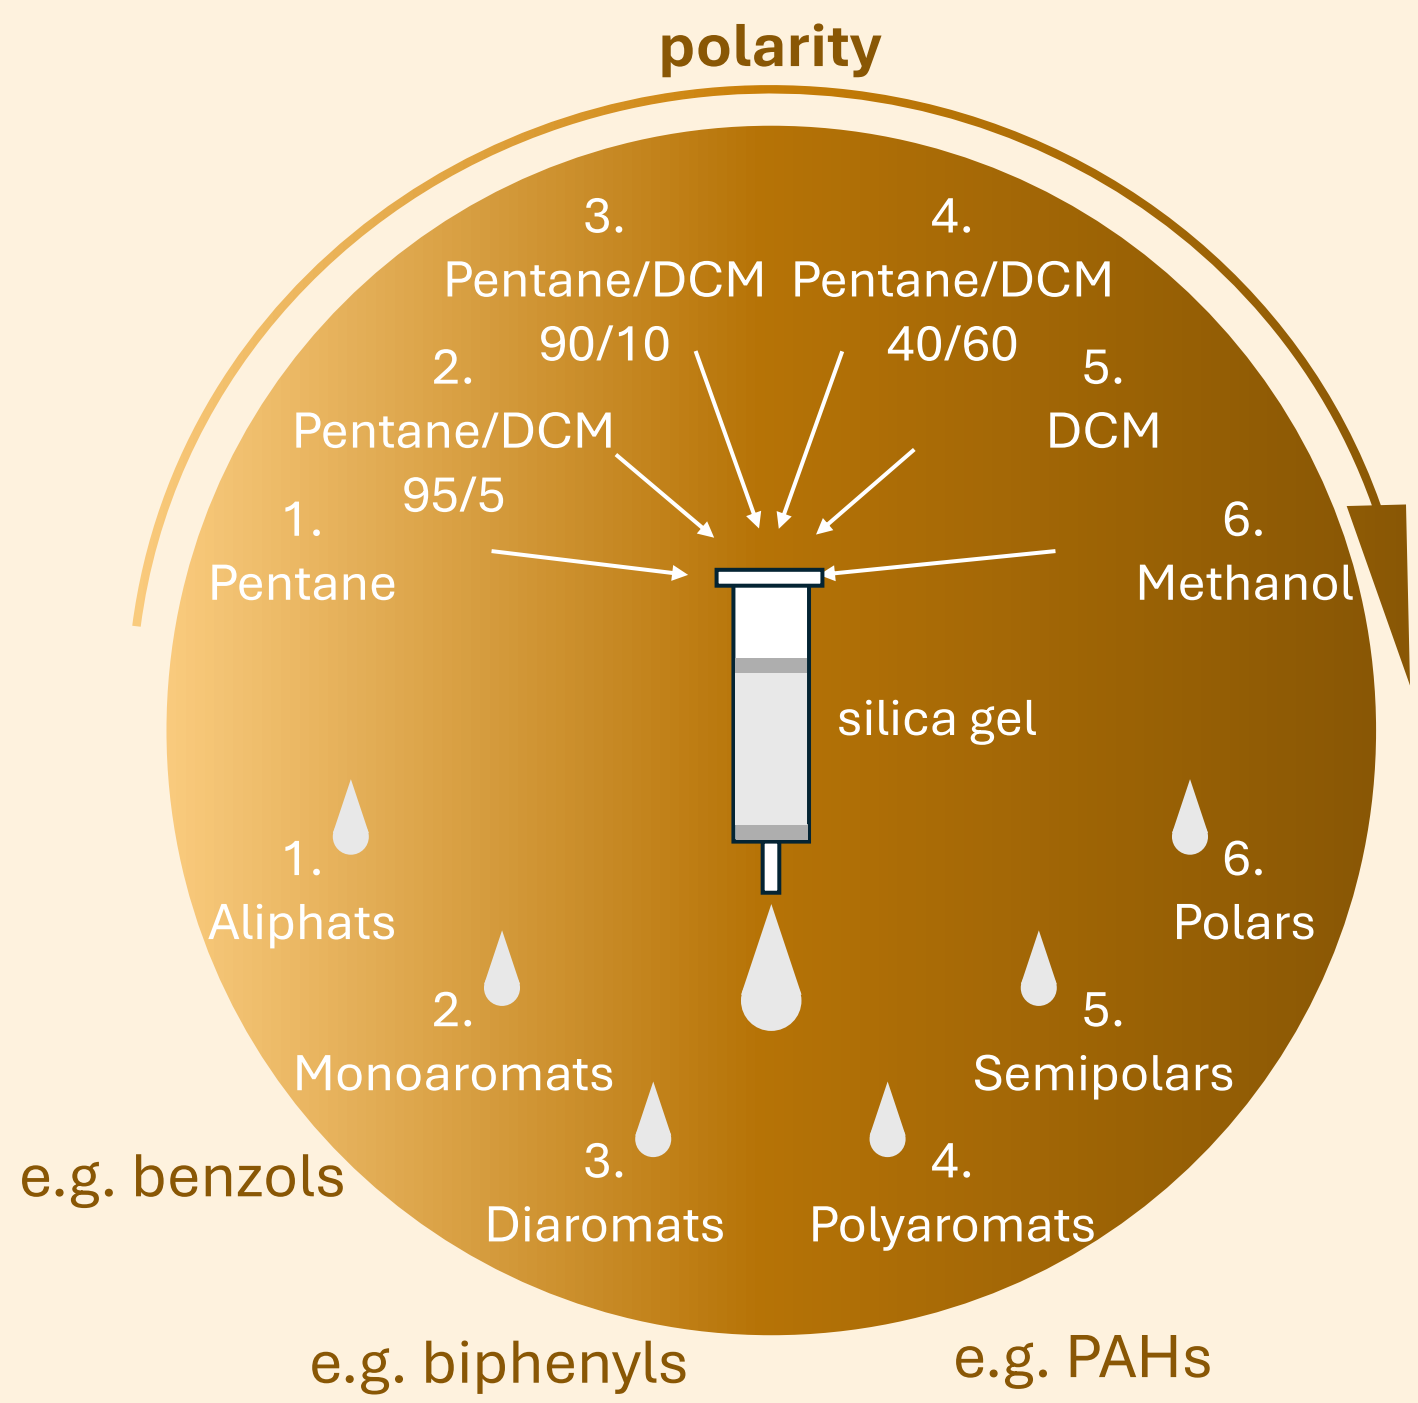
2. Fractionation of extract

The extract is trapped in a stationary phase (silica gel column) and subsequently eluted with solvents with increasing polarity. This procedure generates 6 individual fractions per sample, each including different groups of compounds, effectively reducing peak overlap in chromatograms.

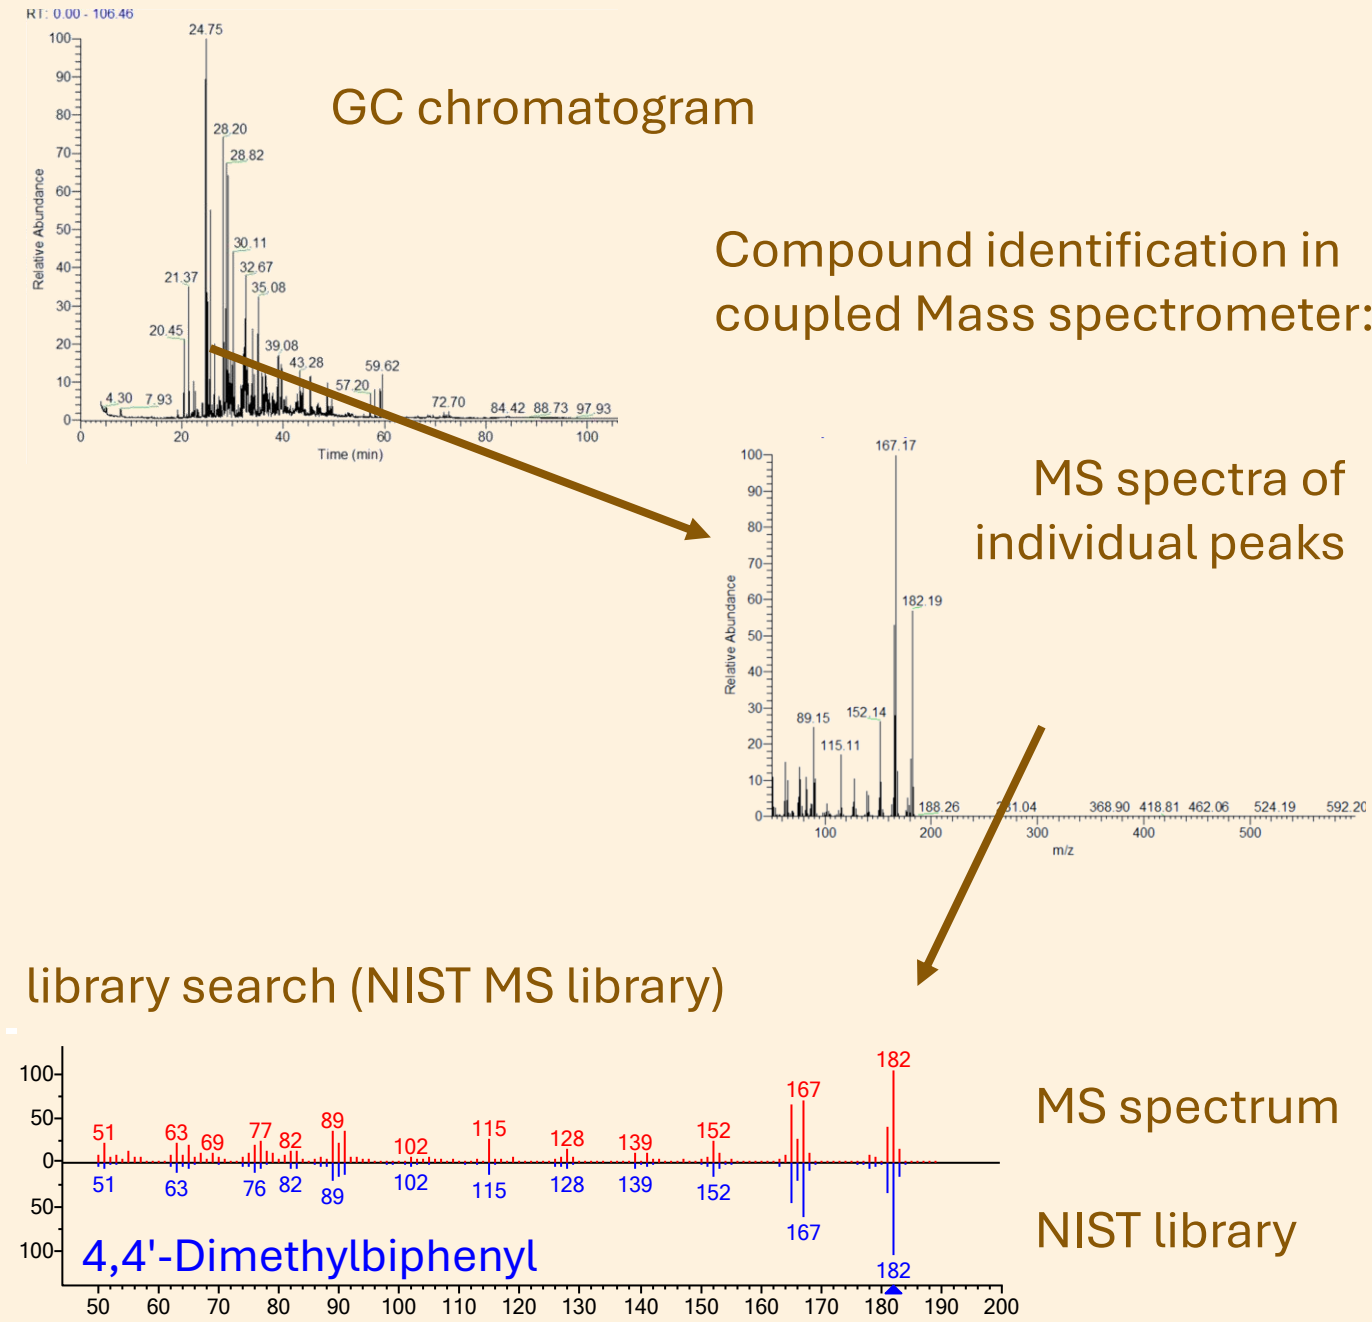
3. Identification of compounds

The 6 fractions are injected separately into coupled GC-MS. In non-target analysis, every single peak in the generated GC chromatogram is evaluated.

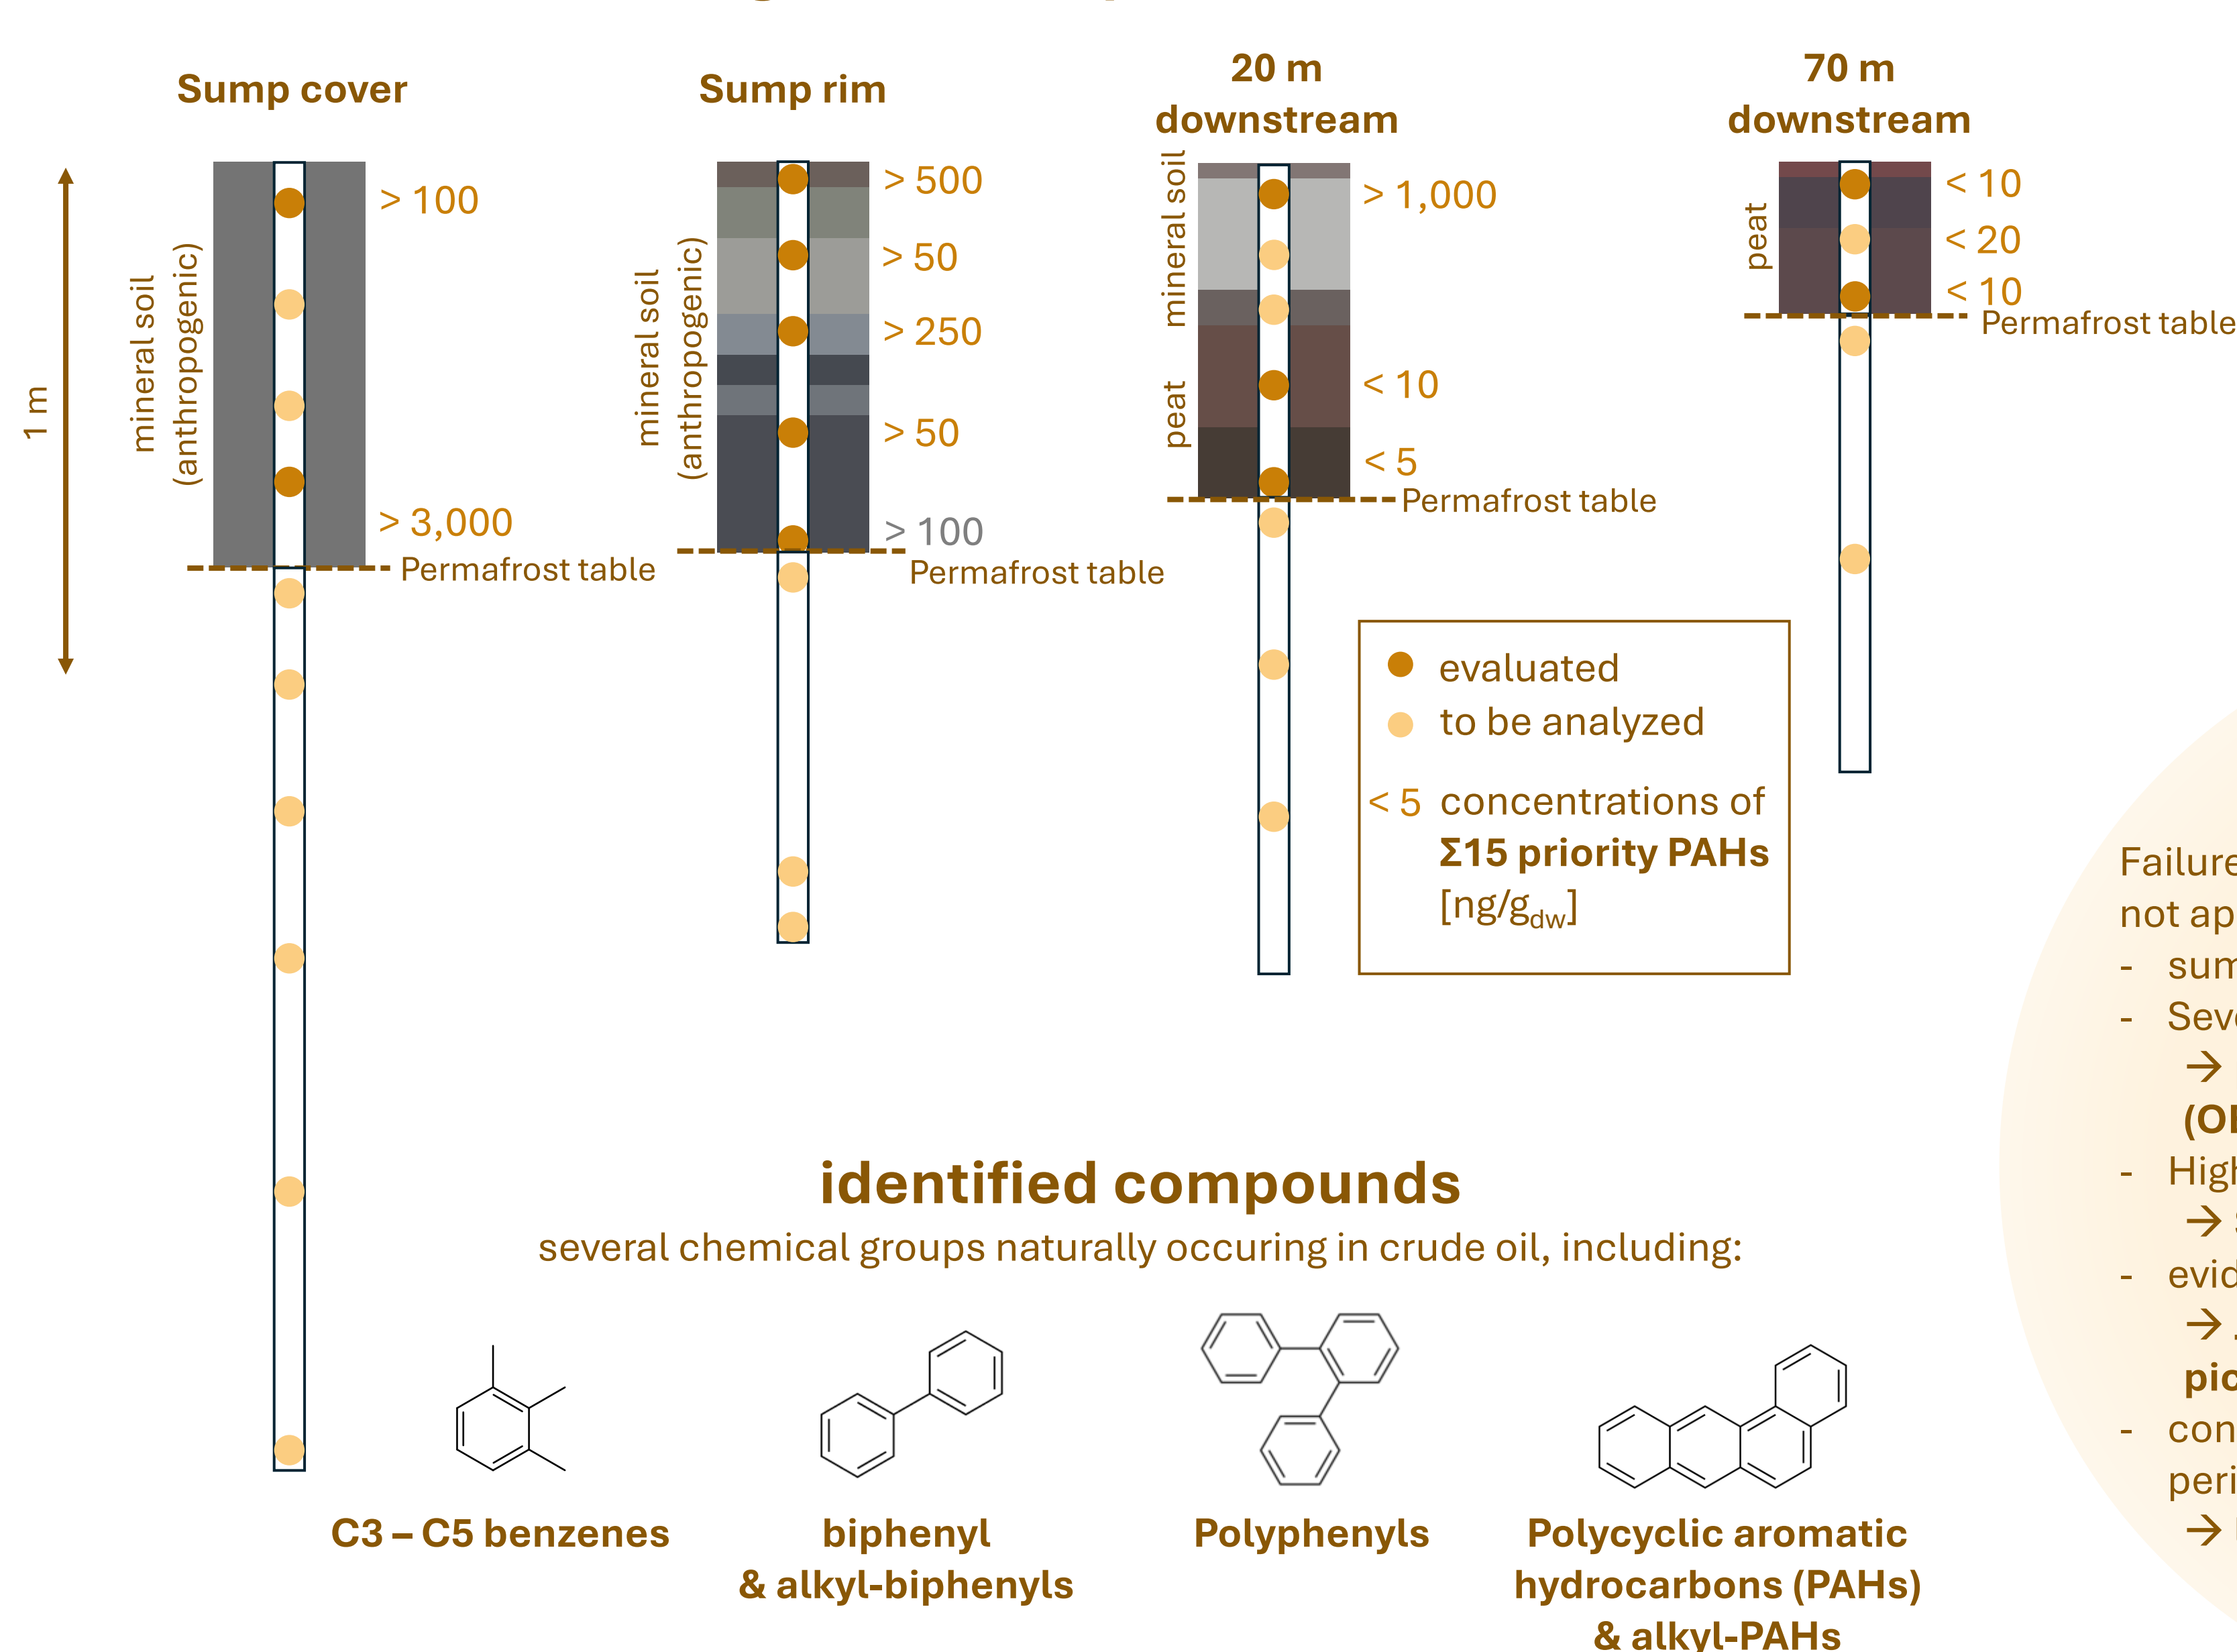
Insights on sump Parsons E02

- Failure of drilling mud sump Parsons E02 is not apparent in aerial pictures, still:
- sump cover highly contaminated with PAHs
 - Several crude oil components were identified → possibility that oil-based drilling fluids (OBF) were used
 - Higher concentrations in greater depth → Surficial soil analysis not sufficient
 - evidence for PAHs outside sump area → Judging sump performance from aerial pictures not sufficient
 - contamination levels decrease strongly in periphery → low mobility or wrong flow direction?
